HOLLAND HOME INSPECTIONS, LLC

RESIDENTIAL REPORT

12345 N Main Street
Anytown, OK, USA

JANUARY 7, 2023

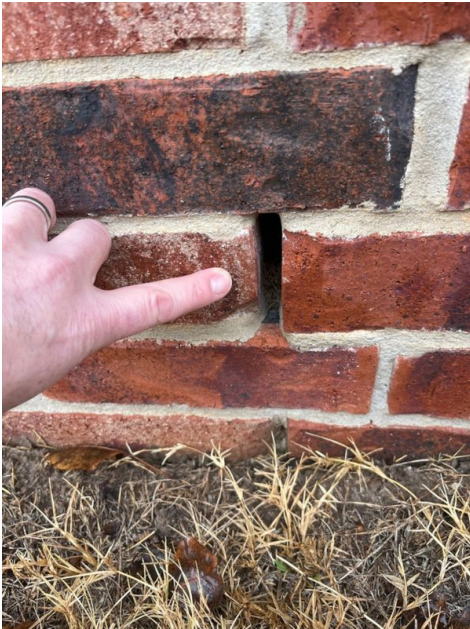
One example

2.2.1 Siding, Flashing & Trim

Brick Veneer Weep Holes were found to be open. This may be or become an entry point for insects or other pests. Recommend installing weep hole protectors designed for that purpose. The proper device will allow water to drain properly, but also keep out unwanted pests.

Recommendation
Recommended DIY Project

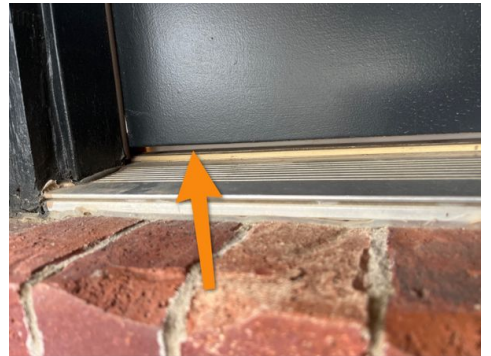
2.3.1 Exterior Doors

Back Door was missing weatherstripping at the threshold. This can result in significant energy loss and moisture/air intrusion. Recommend installation or improvement of weatherstripping.

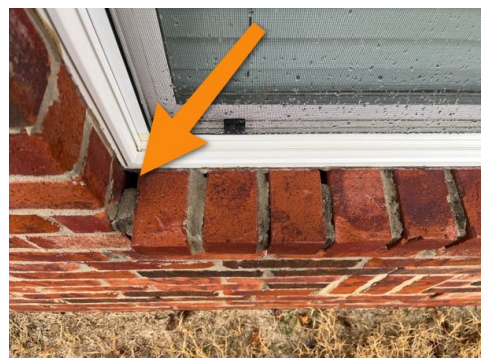
2.4.1 Windows

Window or surrounding area (siding, frame, veneer, etc) was found to have gaps, which may allow the elements or pests in. This may contribute to moisture-related problems, or have a negative effect on the structure. Recommend sealing gaps to prevent water penetration.

Example. Present at several ground floor windows.

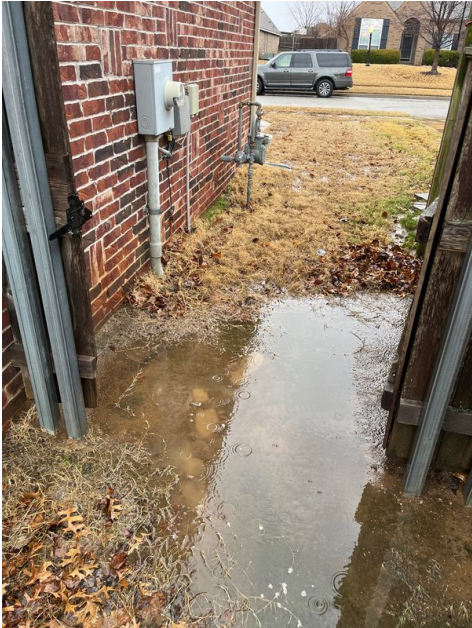
At gate

2.10.1 Grading, Drainage, Vegetation & Retaining Walls

Water was ponding near the structure, indicating poor drainage. Recommend monitoring, and contact landscape or foundations professional to evaluate and remedy drainage.

Even where some splash blocks were employed, standing water and soil washing was noted. Recommend adding drain extensions from downspouts where water ponds and where soil was being eroded.

Recommendation
Recommend monitoring.

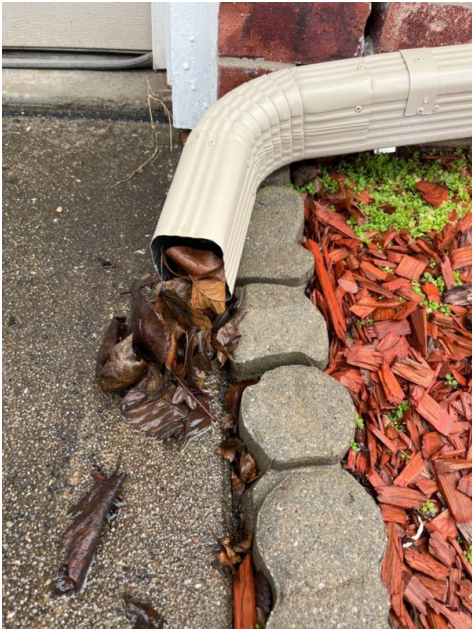
Debris was accumulated in gutter/downspout. Recommend cleaning regularly to facilitate water flow, and to avoid potential water damage or gutter failure, caused by weight accumulation from water. During inspection, water was flowing well.

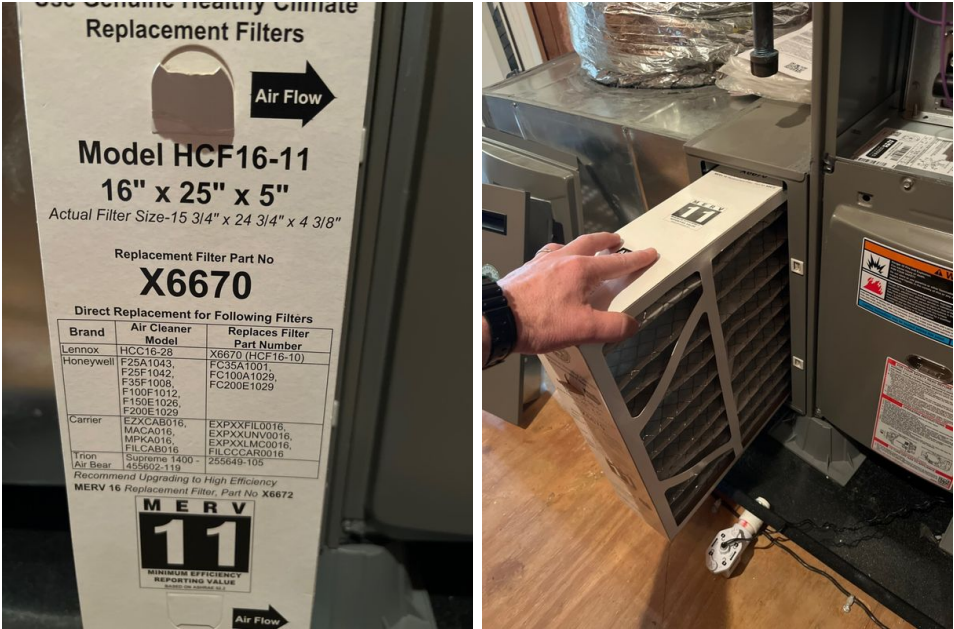
5.4.1 Equipment (2)

The furnace filter was dirty and must be cleaned or replaced regularly. Schedule will be determined by filter style and media type, amount of use, household conditions, and manufacturer's recommendations.

Recommendation
Recommended DIY Project

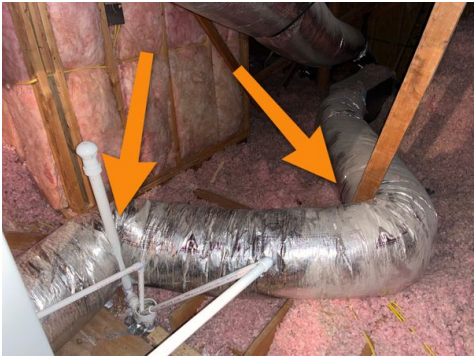
Air Return 1 of 2

5.5.1 Distribution System

DUCT RADIUS TOO TIGHT

Air ducts had tight bends in them which may reduce airflow. If low air flow or temperature irregularities are noticed during use, evaluation by HVAC professional, and possible rerouting are recommended.

Contact a qualified HVAC professional.

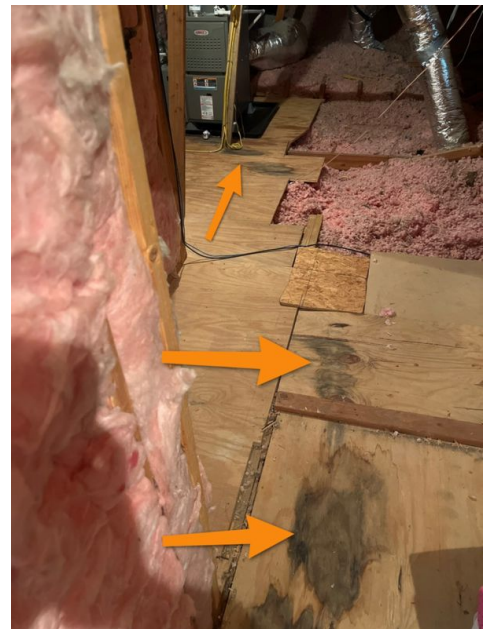
WATER STAINS NEAR REFRIGERANT LINES

Water Stains were found near/underneath refrigerant lines. No moisture was noted during inspection. This may be an indication of previous freezing and thawing of low-pressure line. Freezing may be caused by issues such as restricted airflow, or low refrigerant pressure. It is recommended that an HVAC professional evaluate the system, and make any necessary repairs.

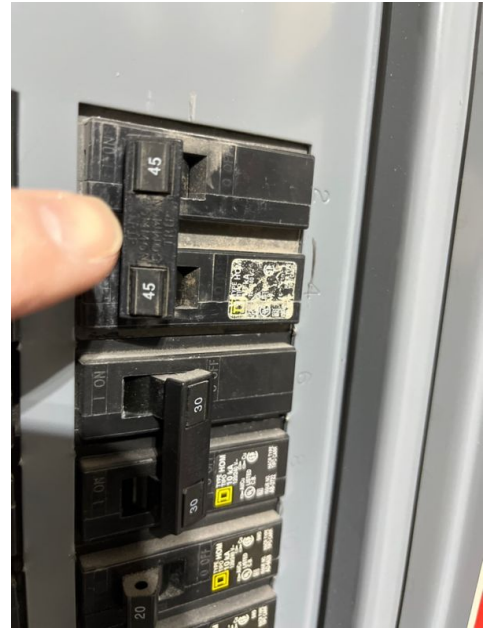
Max 35 listed

AC Unit was found to be on an "over-sized" circuit breaker. This means that the circuit breaker assigned to it is larger than recommended by the manufacturer, and will allow more current to flow than is considered safe for the unit. In this condition, conductors (wiring) may be allowed to heat up due to over-current, potentially resulting in fire, or the unit itself may be otherwise damaged. This condition sometimes occurs when a new, more efficient condensing unit is installed, and the circuit breaker is not changed to match. It is recommended that a licensed electrician evaluate and replace the circuit breaker as necessary.

Contact a qualified electrical contractor.

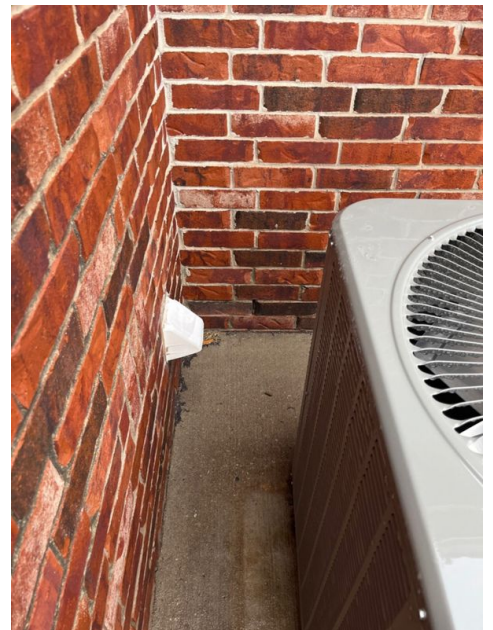
6.5.2 Outside Equipment (1)

Unit was found to be mounted too close to clothes dryer exhaust. This exhaust port emits moist air which may shorten the unit's life. Additionally, it emits any lint which bypasses the dryer's screen. This lint accumulates on the condensing unit's fins, impeding air flow, and negatively affecting operation. It is recommended that the unit be checked for lint regularly, and cleaned with a garden hose as needed.

Recommended DIY Project

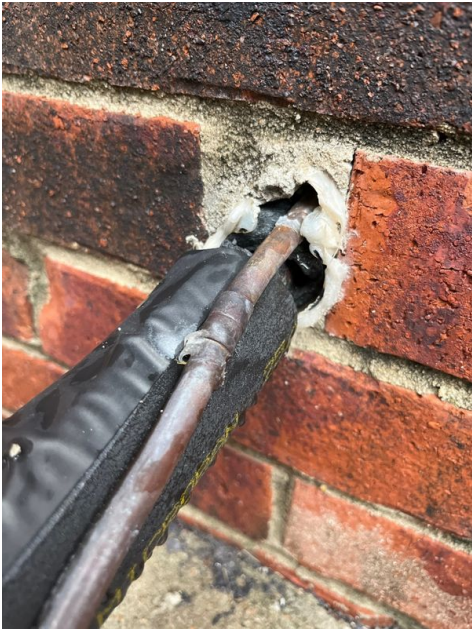
6.5.3 Outside Equipment (1)

Line Set(s) penetrated house through wall. Recommend better sealing this gap to prevent pests and elements from entering.

Contact a qualified professional.

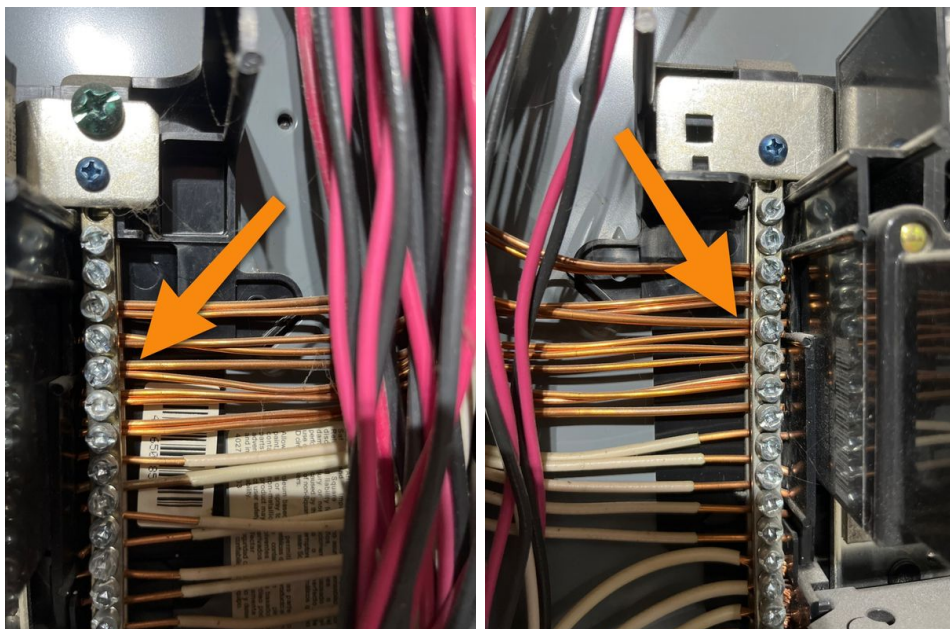
7.4.1 Main & Subpanels, Conductors, Overcurrent Devices

Incompatible grounding conductors were found to be double-tapped. Up to 2 wires may be accommodated under one lug, but must be of the same material and wire gauge. It is recommended that this be corrected by a qualified professional. Conductors of different sizes may become loose, reducing ground's effectiveness, and presenting a safety hazard.

Contact a qualified electrical contractor.

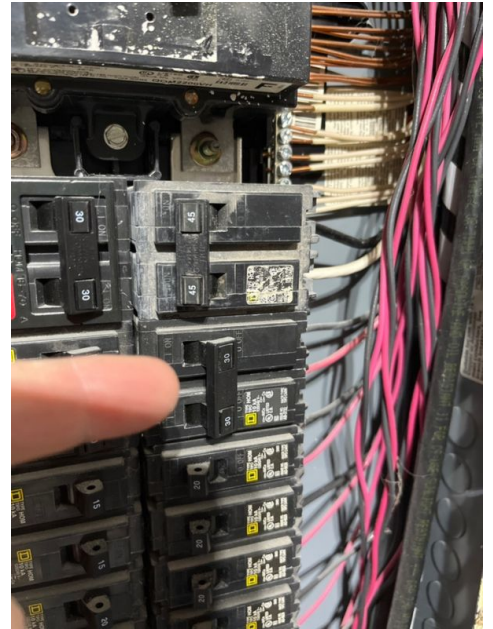
Found Off

7.4.2 Main & Subpanels, Conductors, Overcurrent Devices

BREAKER/FUSE FOUND OFF

An overcurrent device was found in the "off" position. It is recommended to inquire with current owner as to why. If unknown, a qualified electrician should evaluate. This could be due to an unused branch circuit, or due to a known problem circuit or appliance. This 240V circuit was labeled "Dryer", and a 110V gas dryer was noted in the laundry room.

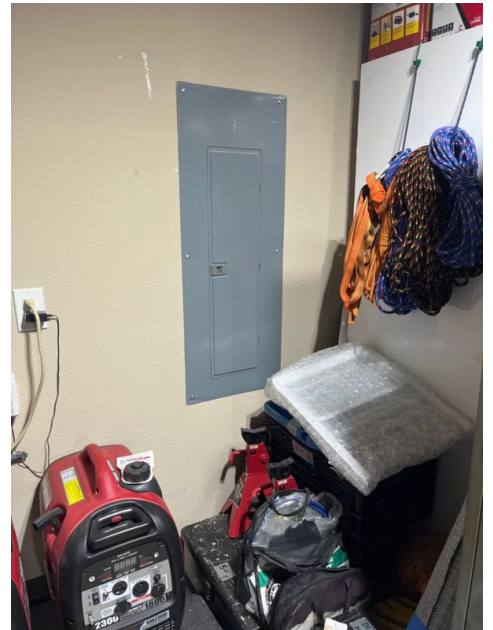
7.4.3 Main & Subpanels, Conductors, Overcurrent Devices

Main Electrical Panel was found to be obstructed. Panel should be provided with adequate clear space for access, at least 30" wide and 36" deep, from the floor surface to at least 78" high. It is recommended that storage be removed and area kept clear.

Recommended DIY Project

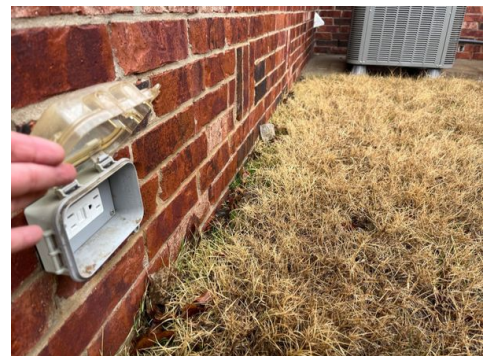
Exterior South

7.7.1 GFCI & AFCI

GFCI FAILED TO WORK

When tested, a GFCI failed to function as intended. These devices are installed to protect a user from electric shock during a ground fault condition. It is recommended that a qualified professional evaluate the GFCI and replace as necessary.

Contact a qualified electrical contractor.

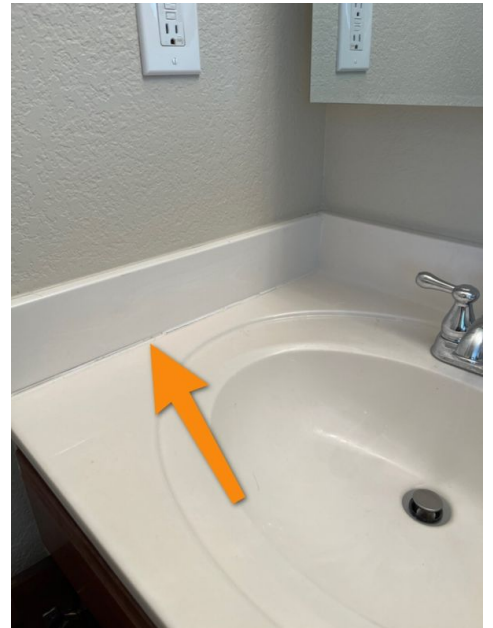
1st floor rear bath

9.8.1 Plumbing Fixtures

Contact a handyman or DIY project

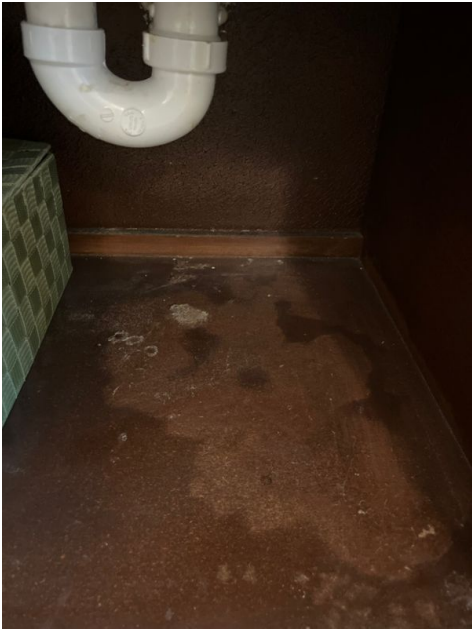
1st Floor rear bath, left sink

9.8.2 Plumbing Fixtures

Signs of previous leakage were noted. Leak was not active during inspection.

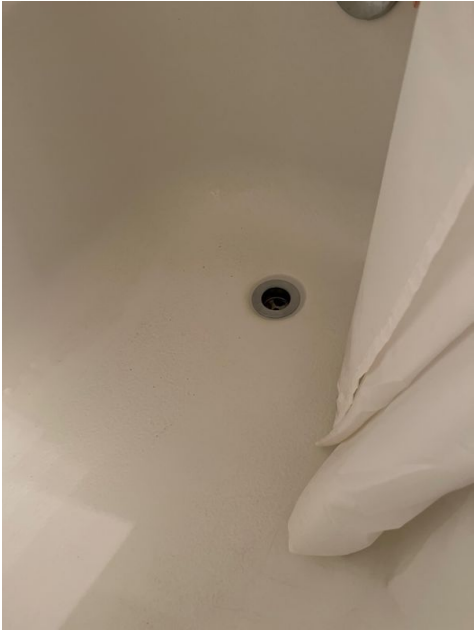
2nd Floor bath

9.8.3 Plumbing Fixtures

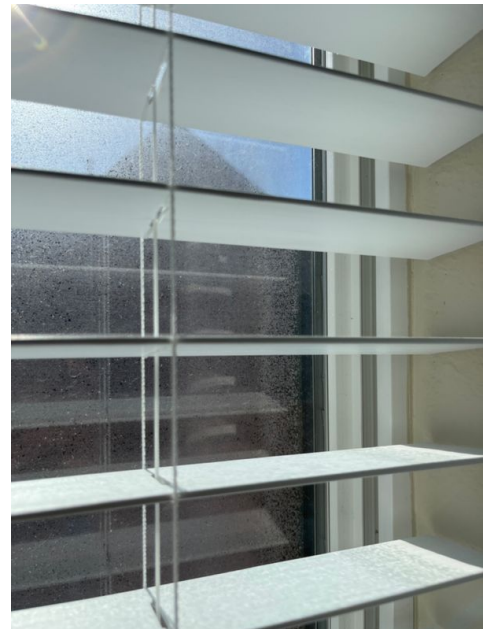
2nd Floor right bedroom

10.6.1 Windows

FAILED THERMAL SEAL

Contact a qualified window repair/installation contractor.

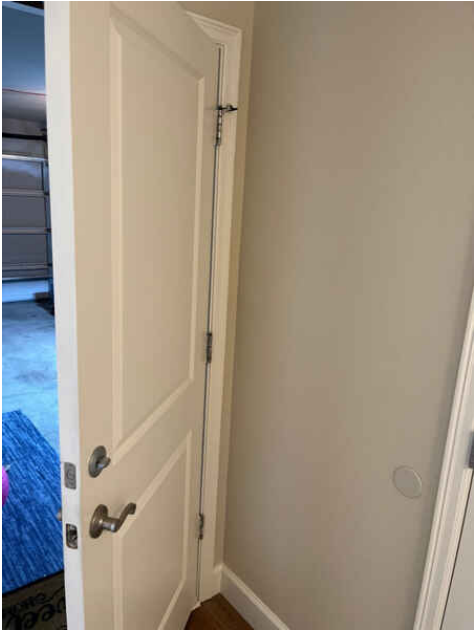
Not Self-closing

14.9.1 Occupant Door (garage-to-home)

Door was not self-closing. Door from garage to home should have self-closing hinges/mechanism to help prevent spread of a fire to living space. Recommend a qualified contractor install self-closing hinges.
